**PRELIMINARY ASSESSMENT/
VISUAL SITE INSPECTION**

**AMERICAN NATIONAL CAN COMPANY
BELLWOOD, ILLINOIS
ILD 005 142 351**

FINAL REPORT

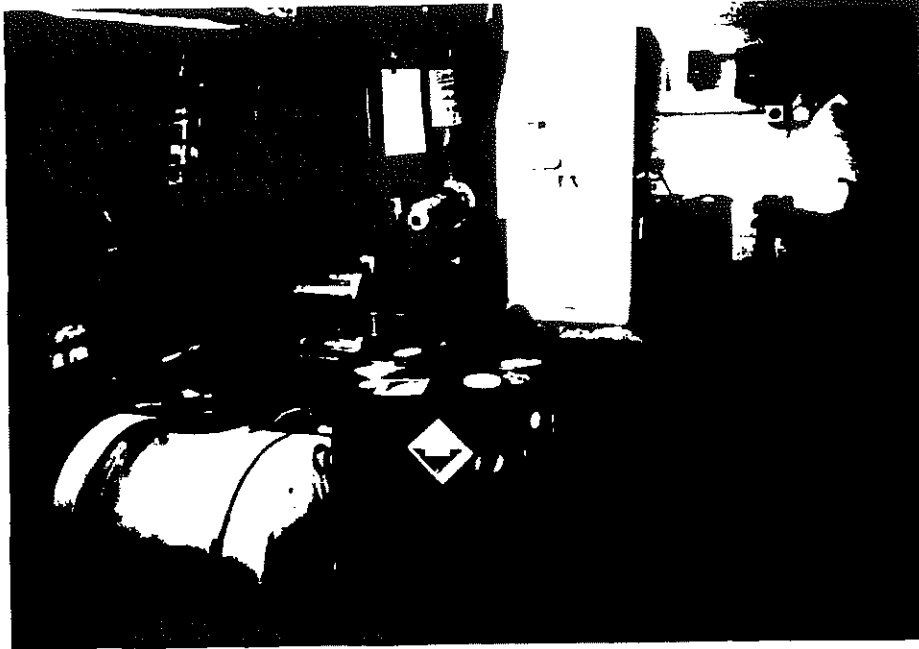
Location: Plate Processing Area
 Date: January 10, 1992

coded, and in good condition. The concrete floor was in good condition with no visible cracks. No evidence of release was noted.

Photograph No. 1
 Orientation: West
 Description: Waste drums in plate processing area (SWMU 1).

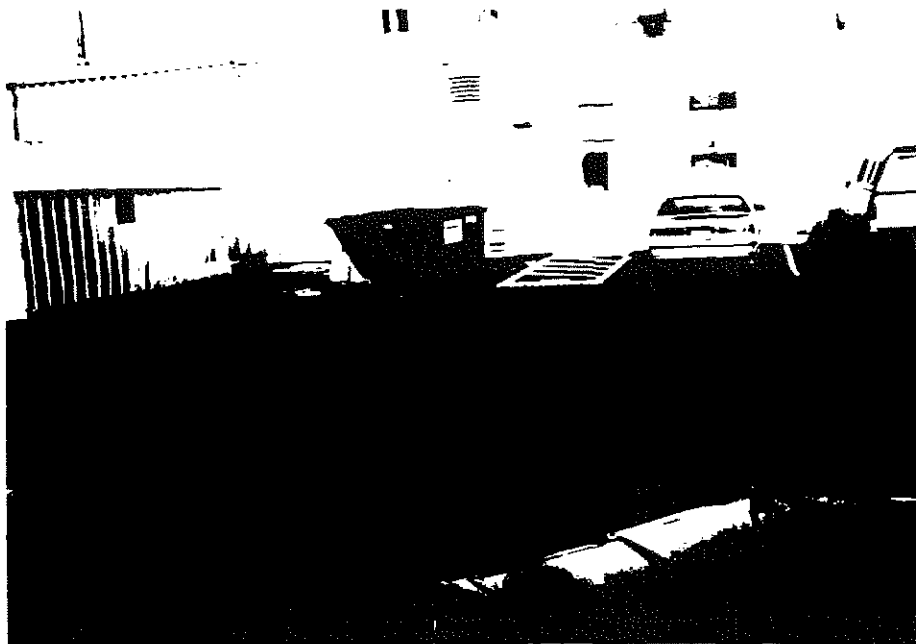
Photograph No. 5

Description: General area where underground tank storage units (SWMU 5) were located.
